PART THREE

Stormwater Management Facilities Program

3.1 Introduction

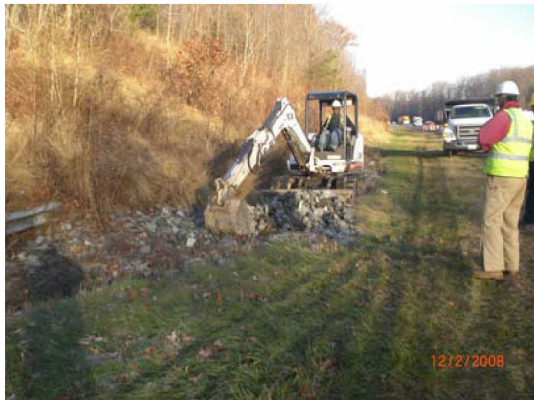
Figure 3-2 BMP 020186 – Removal of Sediment from Infiltration Trench

SHA performs major maintenance tasks that address significant deficiencies at BMPs through the time & material open ended contract lead by Highway Hydraulics Division. The intent is to restore performance of a BMP and/or to avoid failure of specific elements. SWM facilities that require major or remedial maintenance are assigned a "III" rating by SHA. Figure 3-2 shows an example of SWM Facility requiring major maintenance in terms of excavating of accumulated sediments in infiltration trench and replacing the media to restore its functionality.

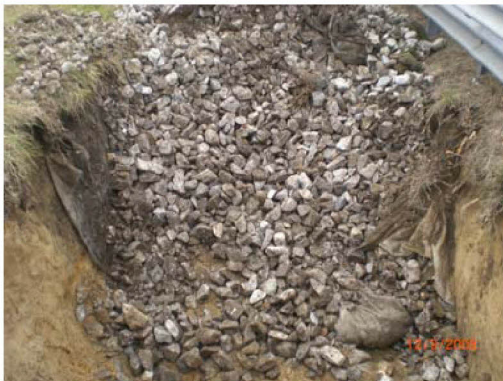
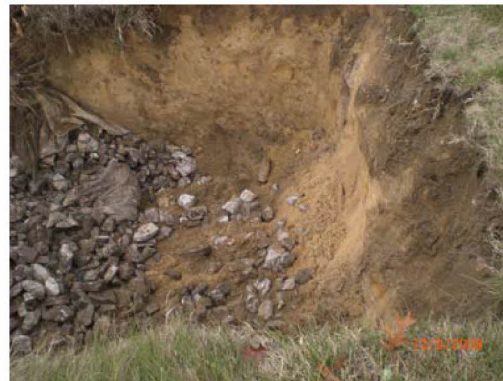
Figure 3-5 Excavation of Infiltration Trench 020191

monitor the trench functionality. The failed infiltration trenches are grouped into individual retrofit projects by which the sites are being redesigned and replaced by more suitable and efficient BMPs. Those retrofit projects are listed in Table 3-5. However, many sites do not allow retrofit to another BMP type due to the topographic and other site restrictions. Those infiltration trenches are replaced in-kind by removal of the existing media and excavating of the accumulated sediment from the trench bottom. In the past year, most of the trenches that have been replaced are located along MD 43 in Baltimore County and along major highways throughout Anne Arundel County. This initiative is demonstrated in Figures 3-5 to 3-7.

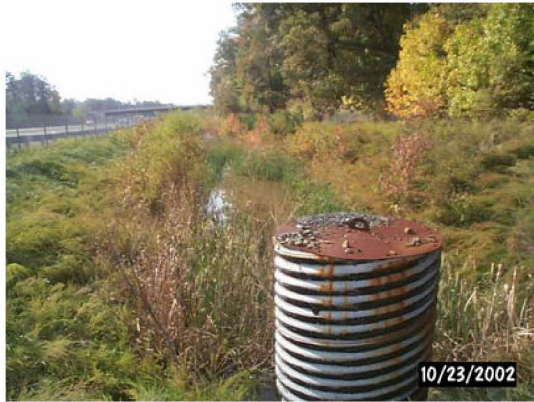
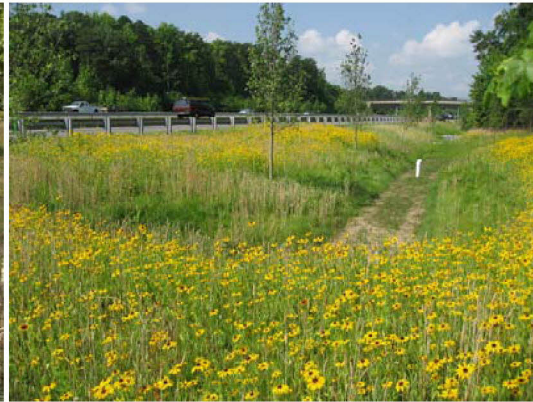
Figure 3-8 Reconstruction of Failed Infiltration Basin into Sand Filter at MD 32 (BMP 020121)

Before the construction (11/2002)

After construction (07/2009)

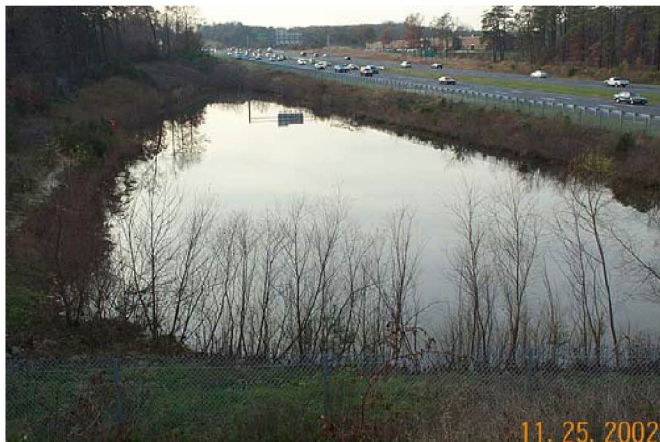
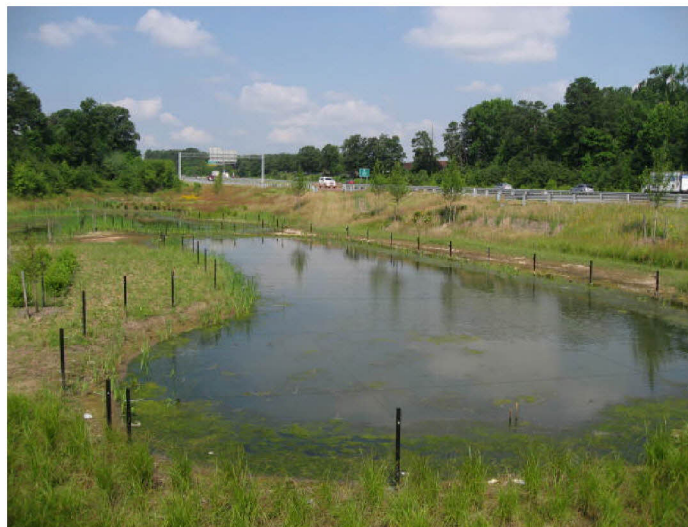
Figure 3-9 Functional Enhancement of Infiltration Basin at MD 100 into Shallow Wetland (BMP 020120)

Before the construction (11/2002)

After construction (07/2009)

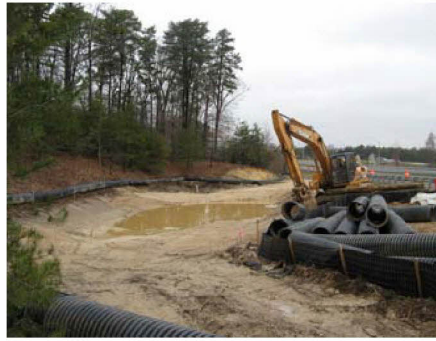
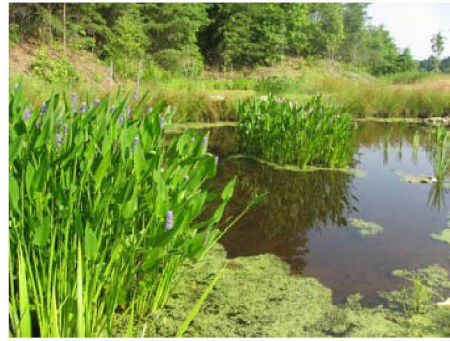
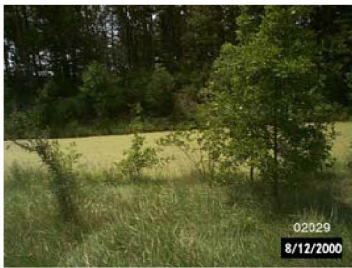
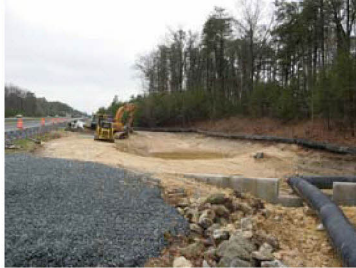
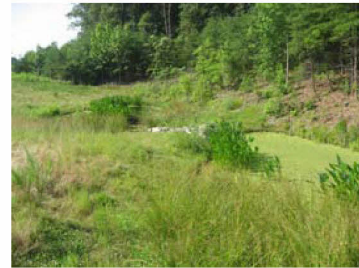
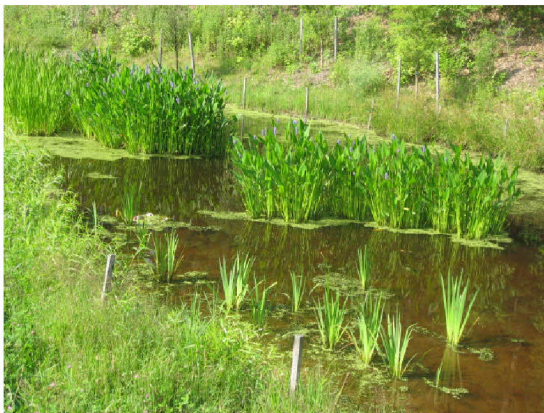
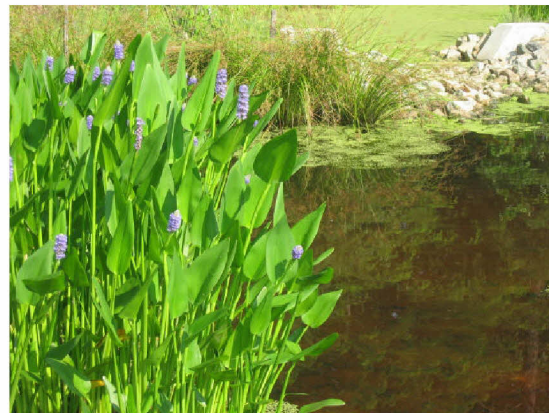
Figure 3-10 Reconstruction of Infiltration Basin at MD 32 into Pocket Pond (BMP020029)

During Construction (10/2008)

After construction (07/2009)

Before the construction (11/2002)

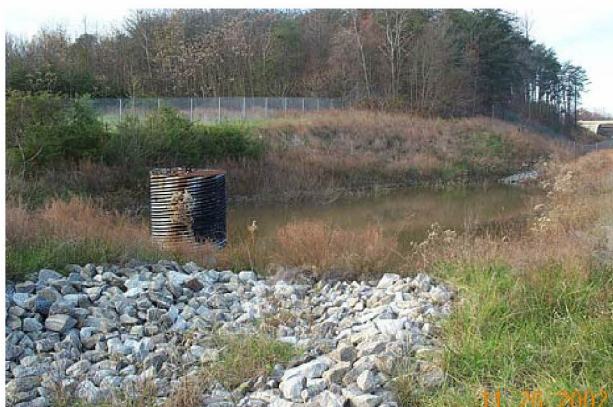
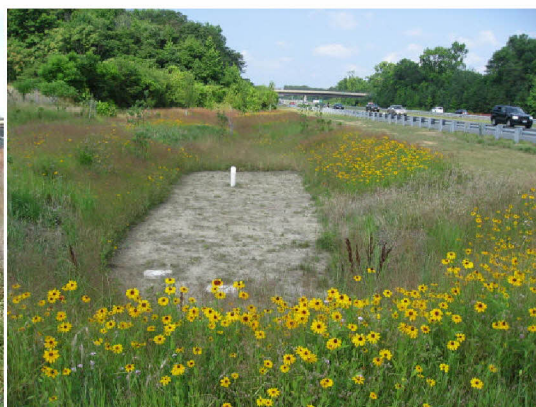
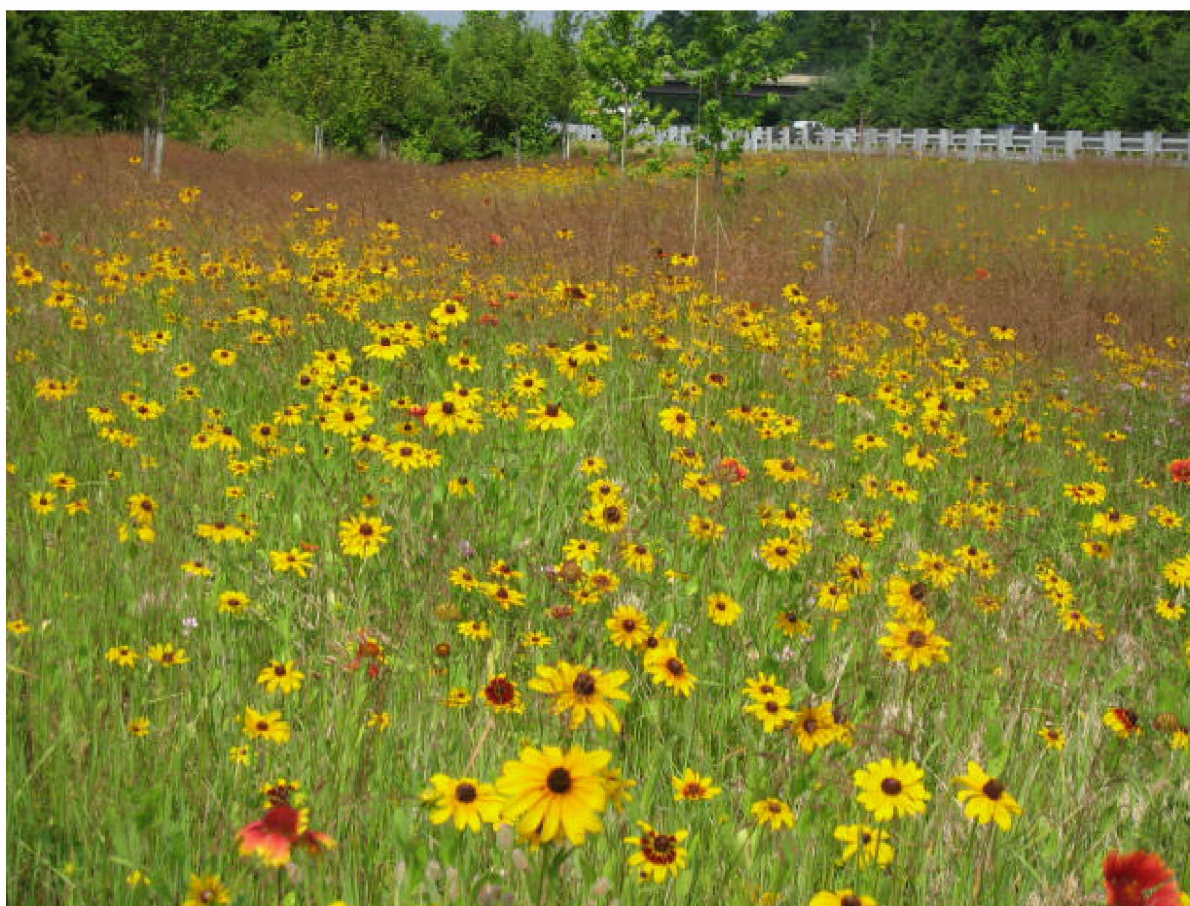
Figure 3-11 Reconstruction of failed Infiltration Basin at MD 100 into Sand Filter (BMP 020122)

Before construction (11/2002)

After construction (07/2008)

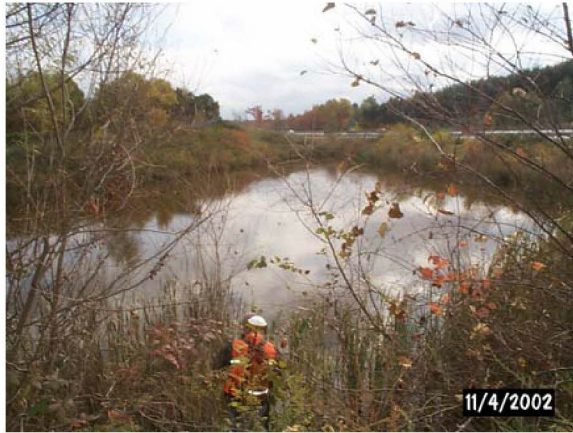
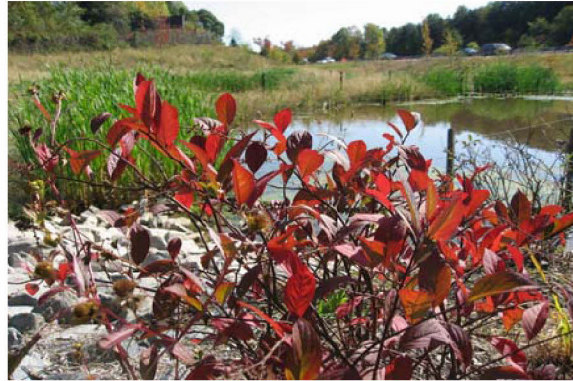
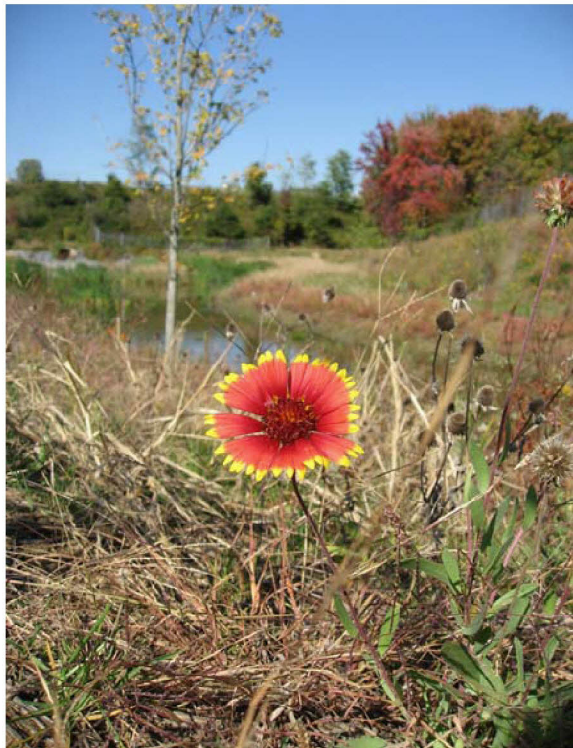
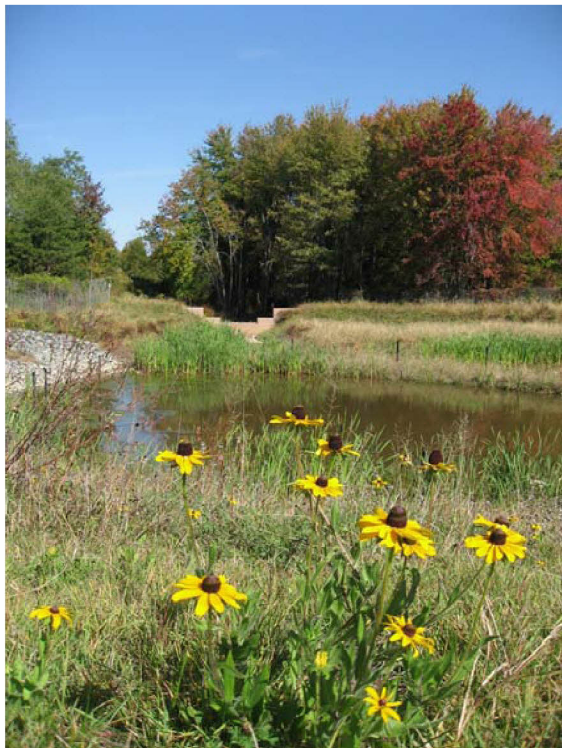
Figure 3-12 Reconstruction of Failed Infiltration Basin at MD 100 into Micro-pool Extended Detention Pond (BMP 020111)

Before construction (11/2002)

After Construction (07/2008)

After construction (07/2008)

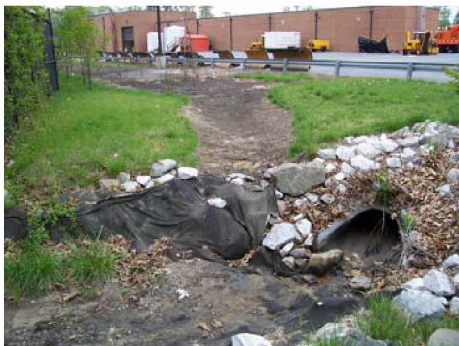
Figure 3-13 Failed Bioretention at SHA Glen Burnie Maintenance Shop

SWM retrofit project of failed bioretention at SHA Glen Burnie maintenance shop includes drainage improvements, outfalls stabilization as well as replacement of the existing BMP with more suitable BMP type for the site – sand filter. The project will be advertised in spring 2010 for construction Figure 3-13 shows the existing condition of the project site.

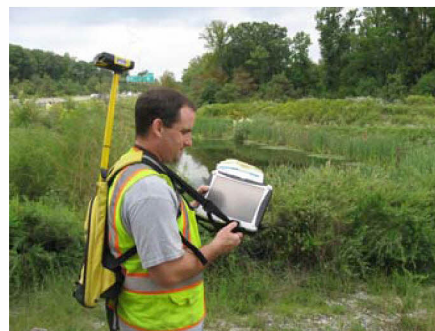
Figure 3-14 GPS and Field Tool Used for Efficient Data Entry During BMP Inspections

In order to stream line geodatabase updates procedure, SHA is developing automated Office Tool for quality assurance (QA) checks. In addition, a Field Tool has been developed for new field data collection, downloads and merging with main database. See Figure 1-14.

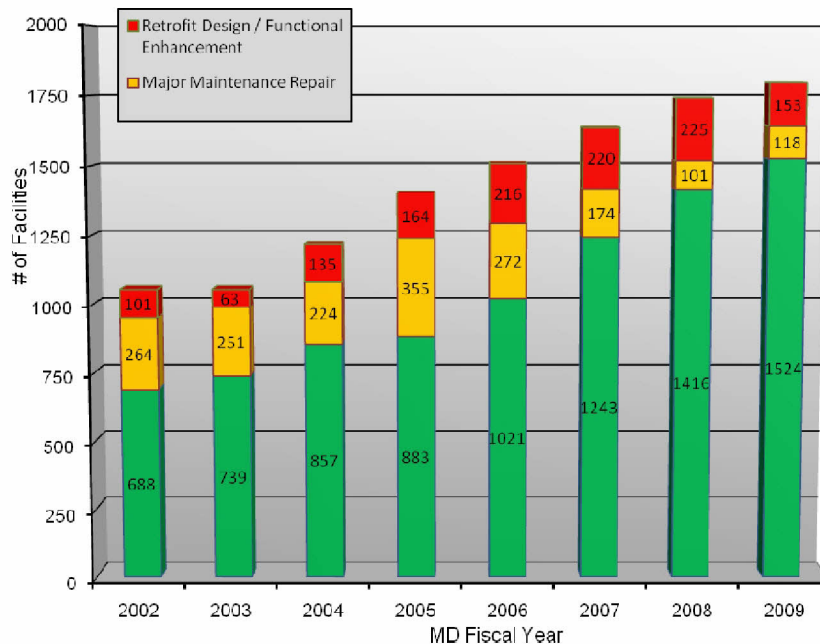
Figure 3-17 Progress in SWM Facilities Program

The SHA Business Plan goes beyond the NPDES permit jurisdiction by promoting the statewide inventory and a high-level of BMPs performance. The goal is to bring 90 percent of all SHA owned SWM facilities to their functionality by FY 2012. Currently 84.9 % of SHA inventoried facilities function as designed. Figure 3-17 summarizes the progress.
